## Test Report

No.: NBHL260802659701OT

Sample Description : PPR MATERIAL

| Test Requested | Test Result(s) |
|---|---|
| US CPSC 16 CFR 1500.44 – Method for determining extremely flammable and flammable solids | Pass |

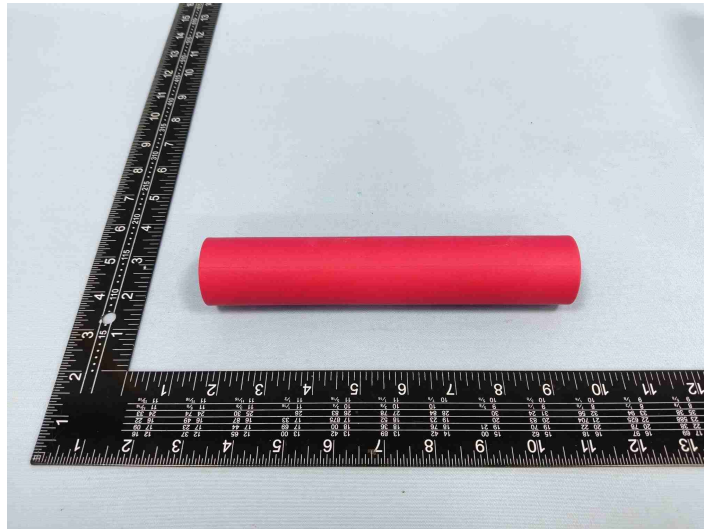
### Sample Photo:

Sample  
PPR MATERIAL

Burning Rate (inch/sec)  
DNI

DNI = Did Not Ignite
